HEAVY-LIFT BREAKBULK SHIP PRETEST RESULTS OF THE JOINT
LOGISTICS-OVER-THE- (U) ORI INC ROCKVILLE MD
H CASEY ET AL. 25 JUL 77 ORI-TR-1168 MDA903-75-C-0016

25 JULY 1977

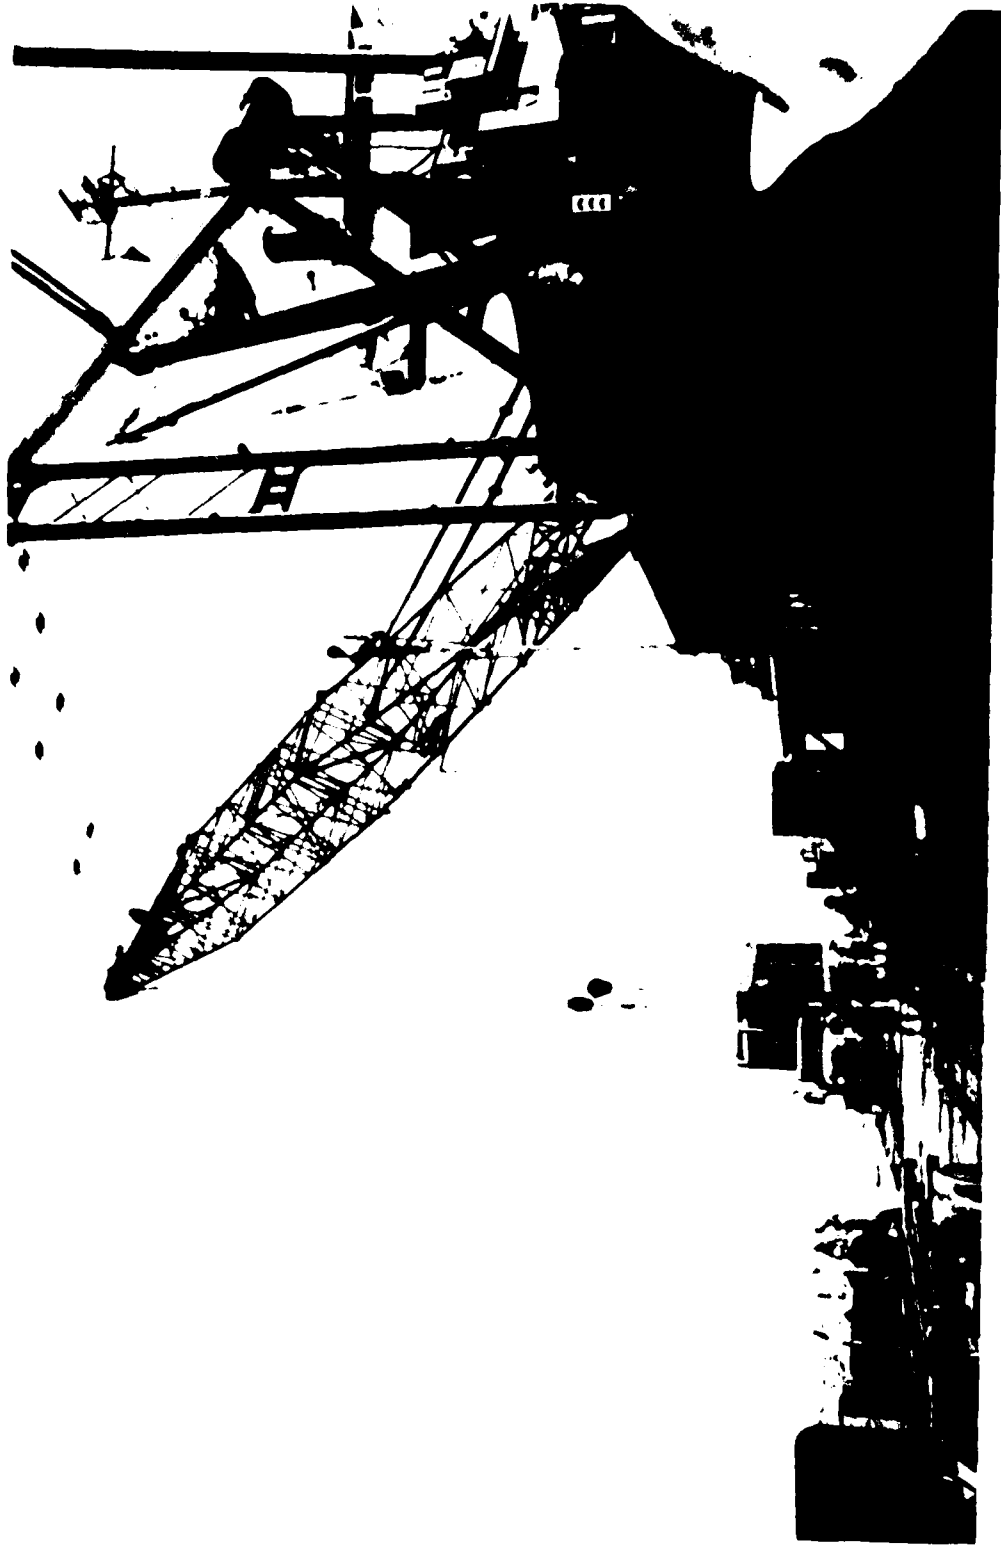
FIGURE D-44. SPREADER BAR NOT ALIGNED. With a two-point spreader bar attachment and automatic taglines, the spreader bar and container were nearly always perpendicular to the boom, while the trailer chassis was not. This necessitated man-handling the container until it was in a position that would permit lowering the trailer corner fittings.

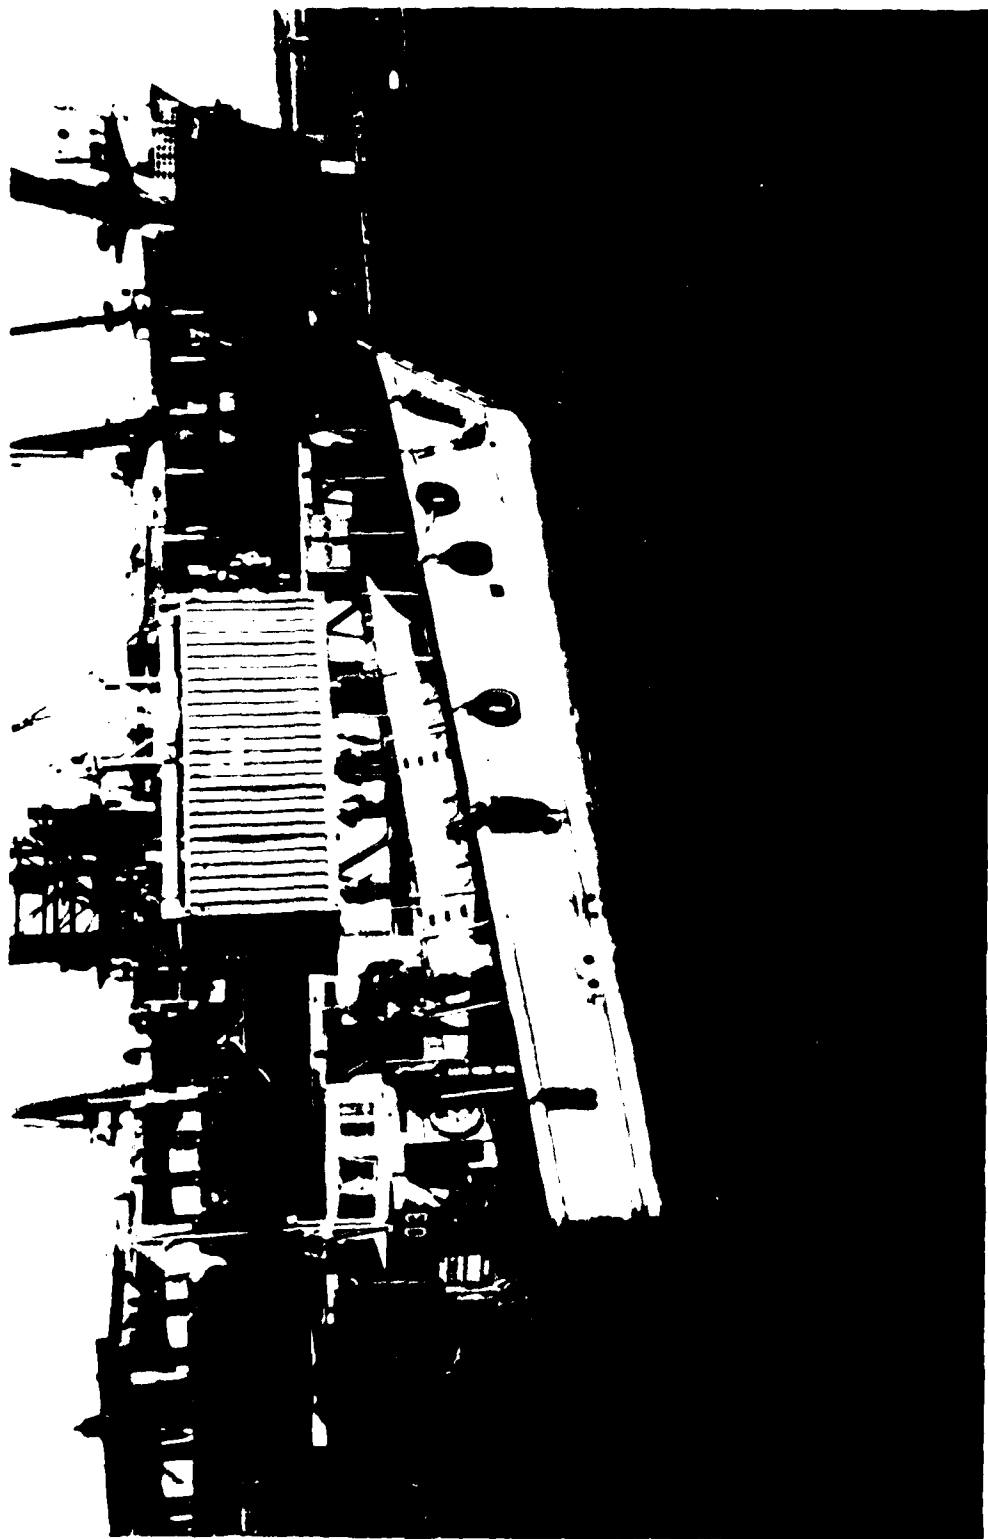
FIGURE D.46. LCM8s USED. LCM8 landing craft received extensive use in the pretest and had better beaching capabilities than LCUs, although both were unable to beach close enough to shore cranes at low tide.

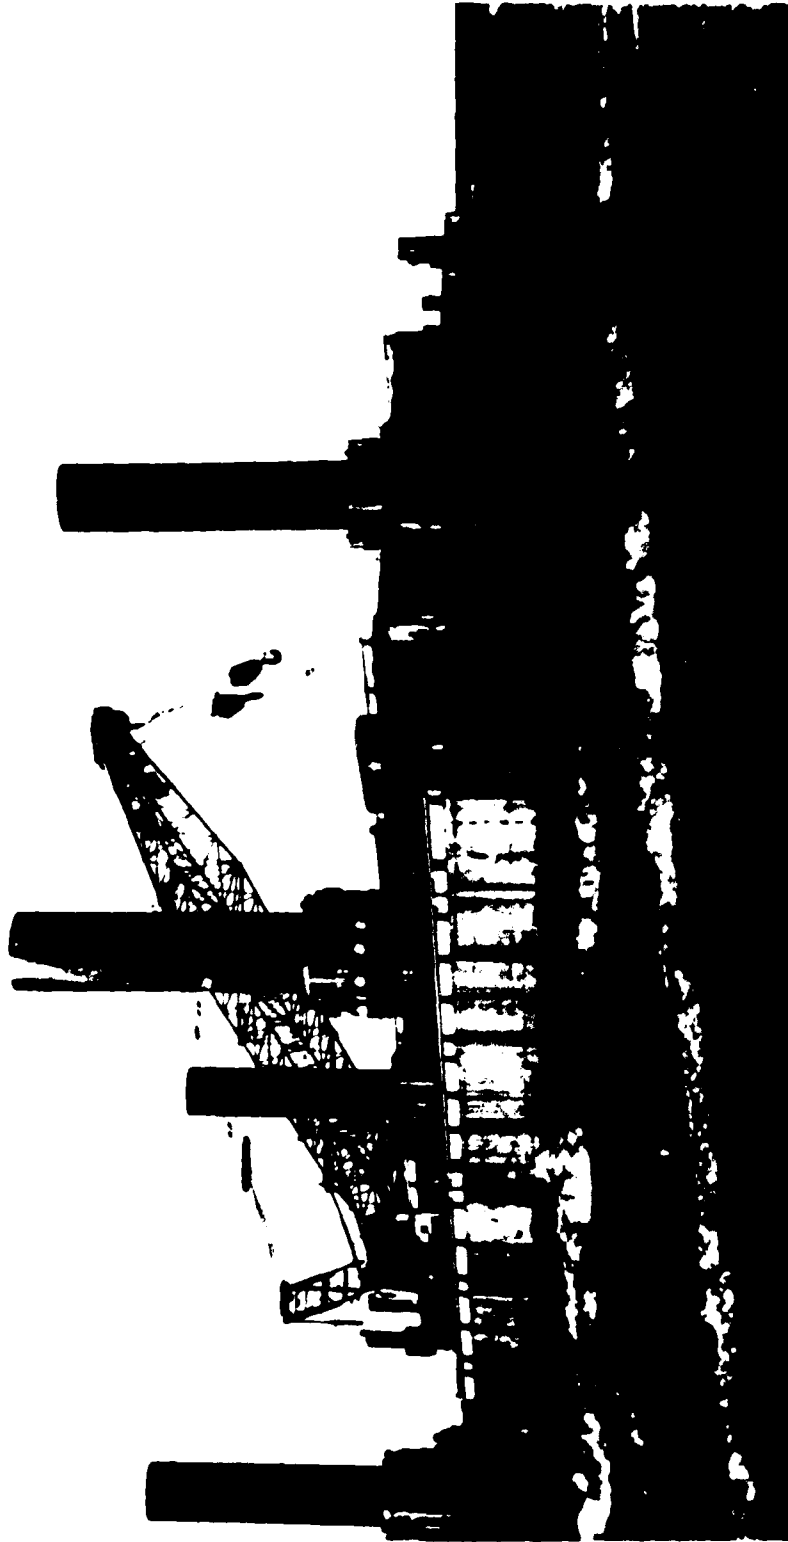
FIGURE D.47. DELONG PIER POSITIONED. To improve shoreside unloading capabilities a 140-ton crane was positioned on a DeLong barge and towed to the objective area. The DeLong was beached using two LCMs. Later the DeLong was jacked-up out of the water on its pilings and ramps were added so that trucks could drive from the beach onto the pier.

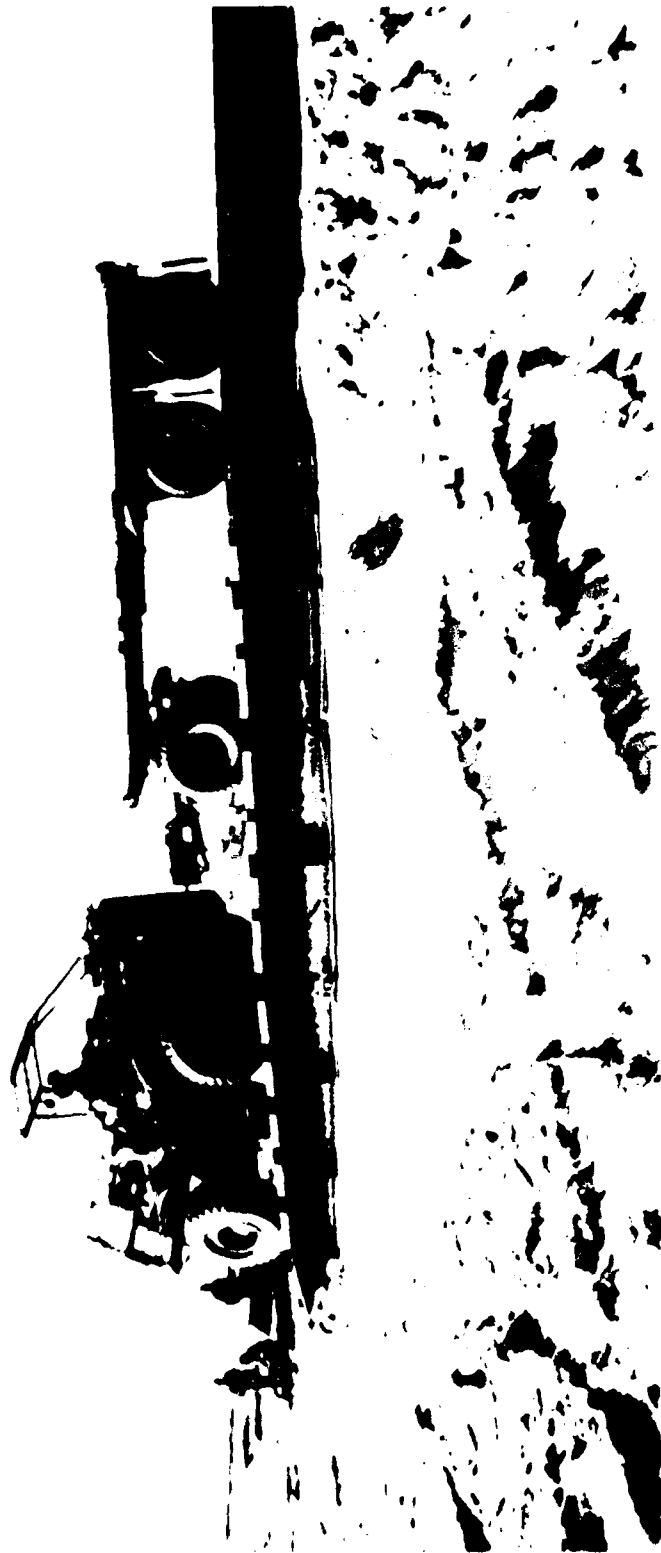
FIGURE 1.50. ABOVE: AL-BLEMS. Truck drivers experienced difficulty backing their trailers up the ramp so a rough terrain forklift, which has articulated steering, was tried. The above ALB ramp connects onto the Pelong ramps. The ALB ramp was subsequently replaced by a sand ramp.

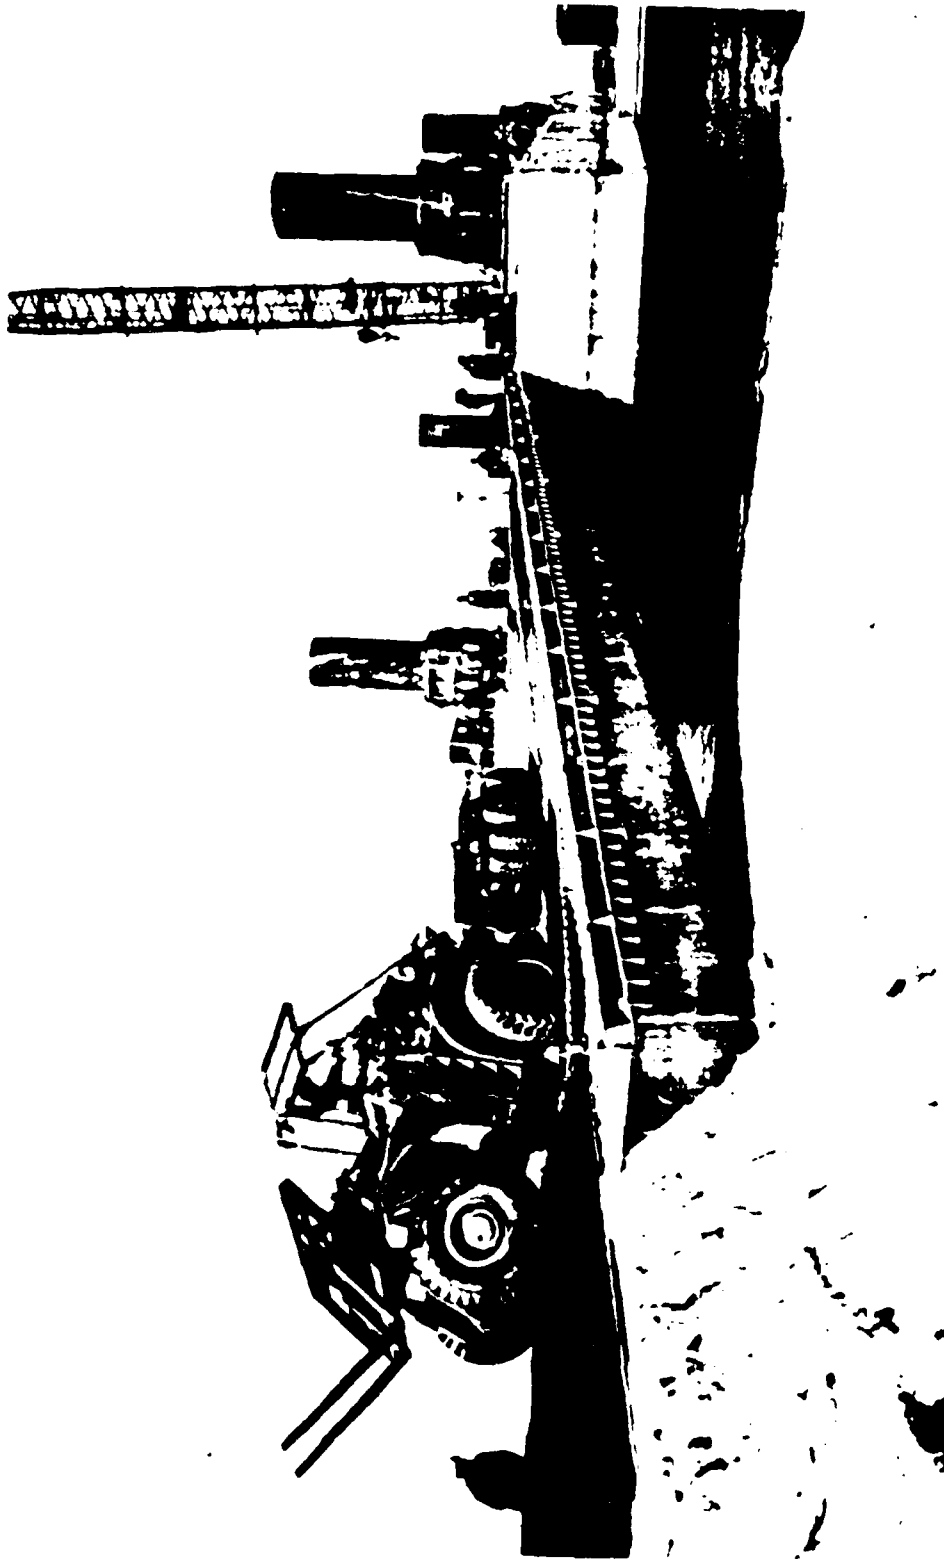
FIGURE D.51. CRANE DELAYED. Until the trailer was positioned under the crane, operations were choked. With experience drivers were able to more rapidly back their trailers up the ramp.

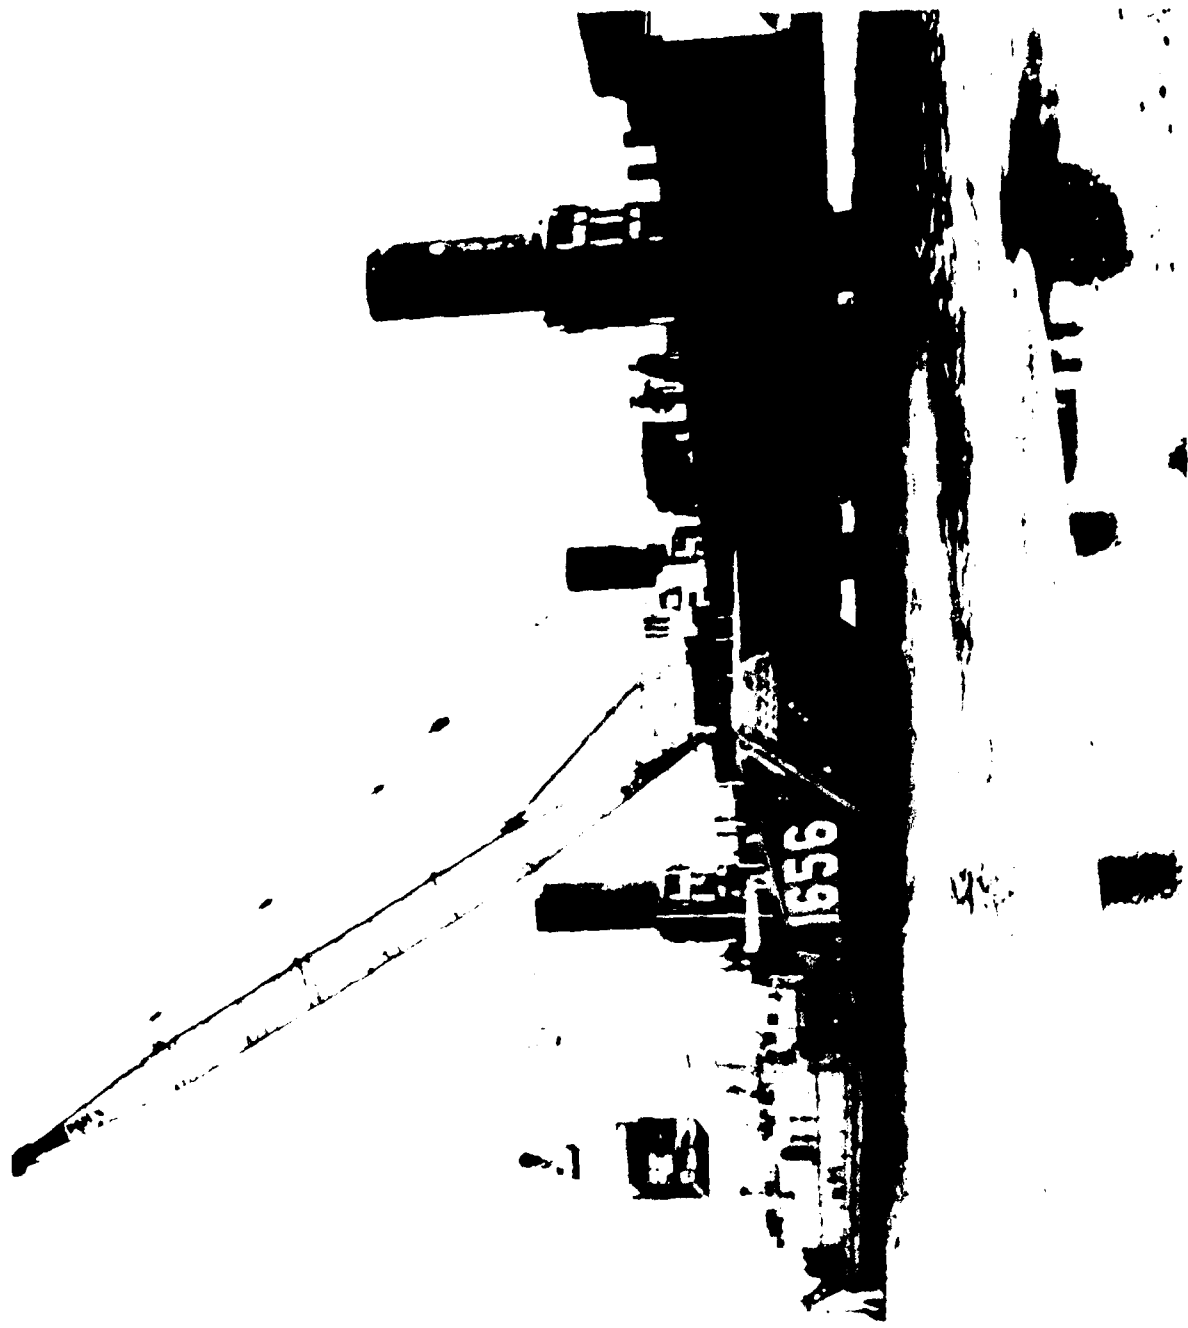
FIGURE 1. TRAILER IN POSITION. Once the milvan chassis was on the
beach, it was quickly loaded.

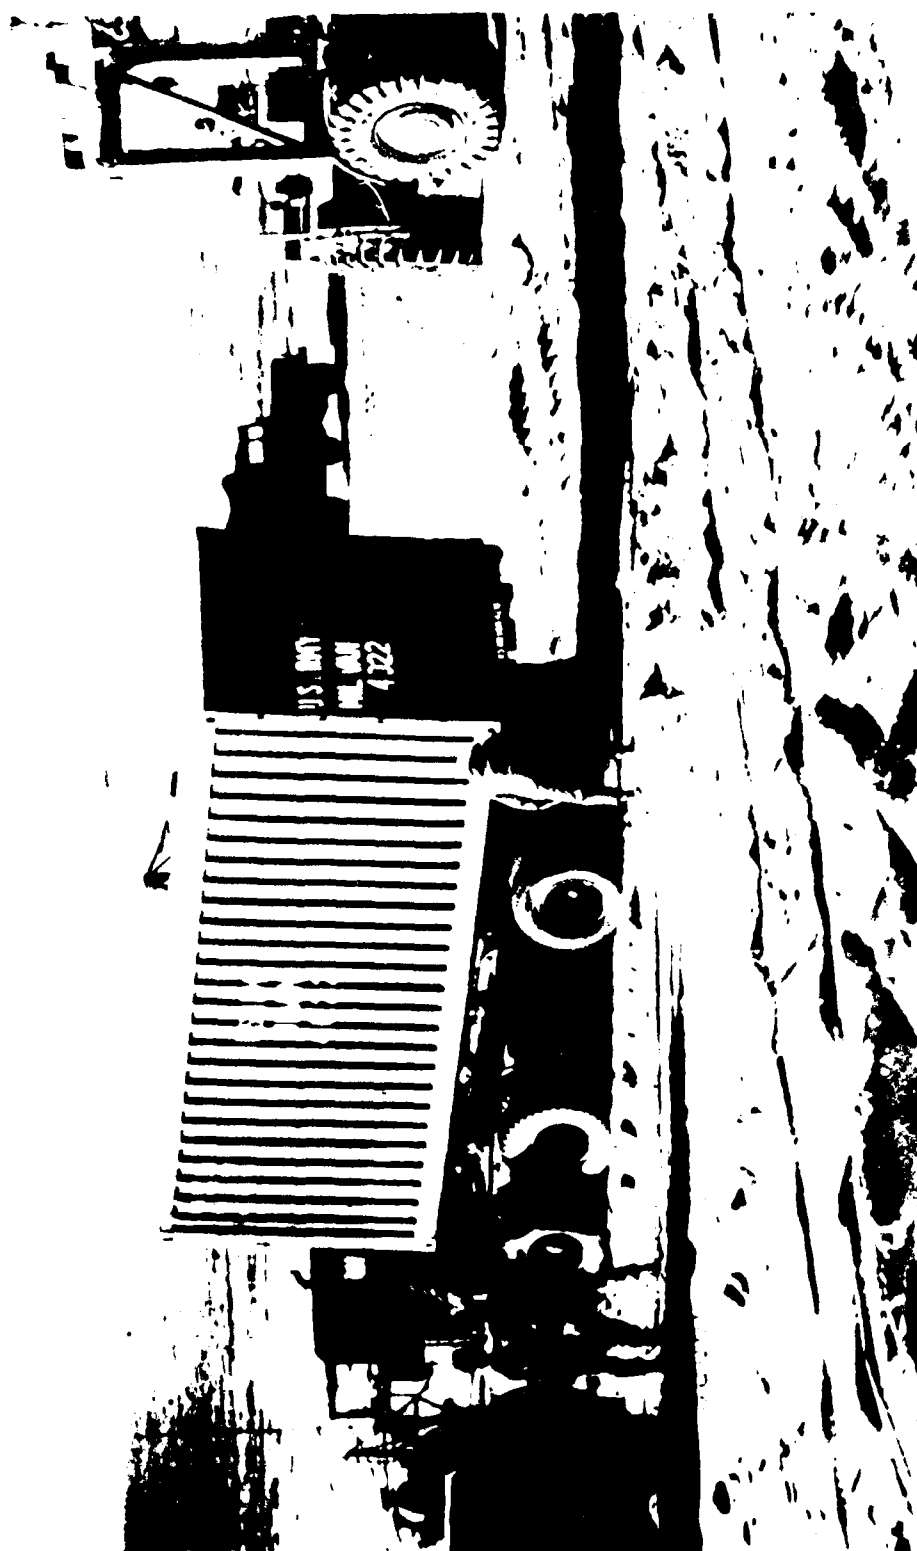
Fig. 1. The vehicle shown in the photograph above is loaded above by the front loader. The tire container was lifted up in the causway, and the tire was loaded onto the chassis required approximately 4 minutes.

For unloading the ferry on shore the frontloader was very effective. Since only one unit was slow since the same frontloader was also used to position each container on a trailer. The five containers were unloaded in just over 1 hr, or approximately 68 minutes each. If two front loaders had been available this time could have been greatly reduced. An empty loader could move onto the causeway immediately after its predecessor left with a load. Another way to reduce the causeway unloading time, at the expense of some double handling and possible truck delay, would be to have the single frontloader drop each container at a point near the causeway until it was unloaded. Then the frontloader would load trailers until another loaded causeway ferry was beached.

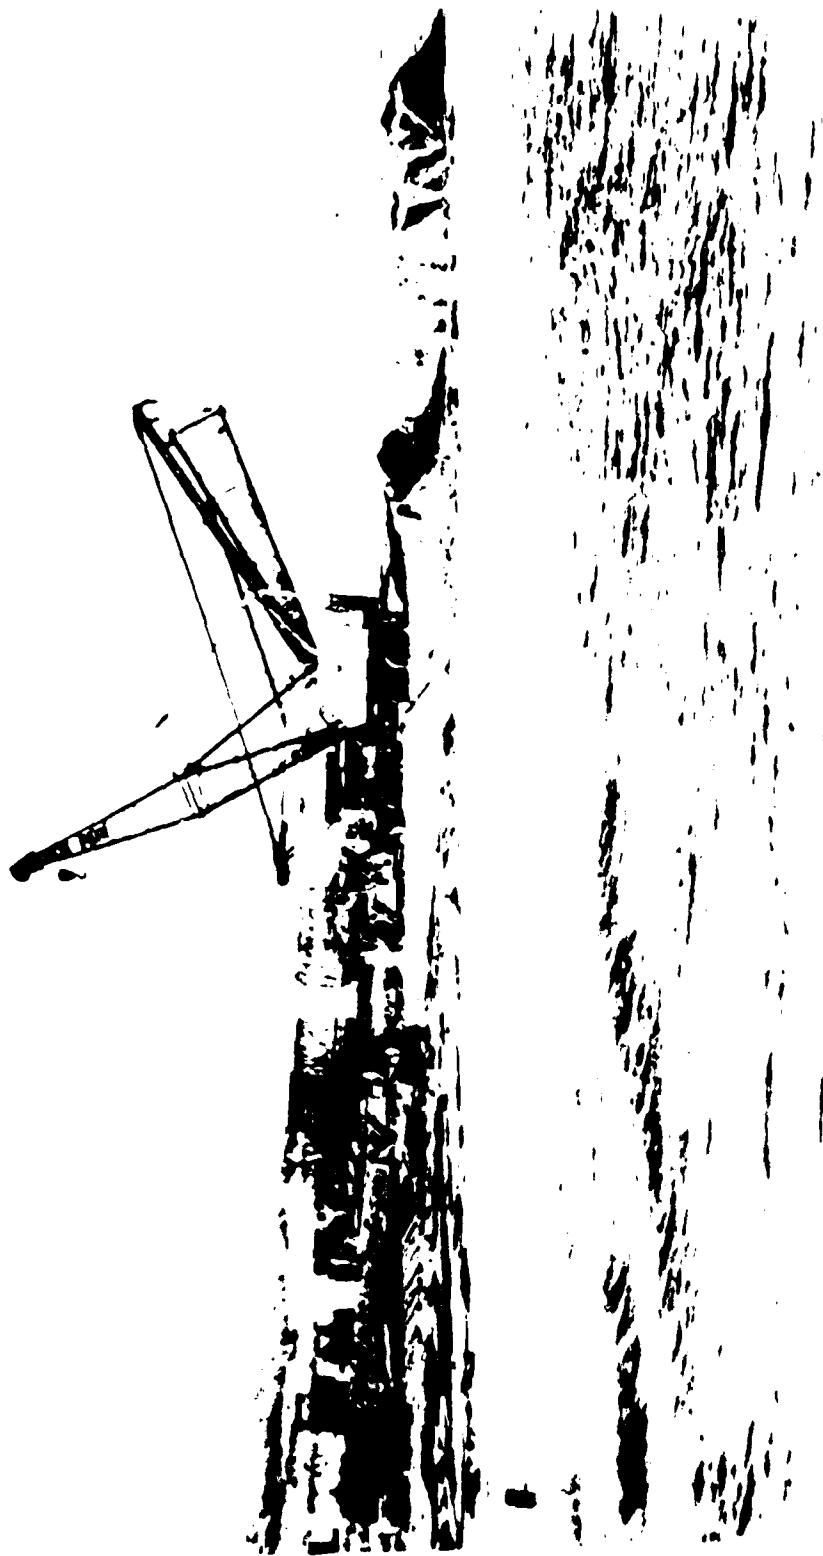
FIGURE 1. BEACH CRANE ASSEMBLY BEING. Once the 300-ton crane was landed and turned around, its assembly could be completed. It required 7 days before being operational, although no night operations were conducted and some of that time were spent reversing the crane due to the necessity of loading the crane in a manner opposite to its original orientation.

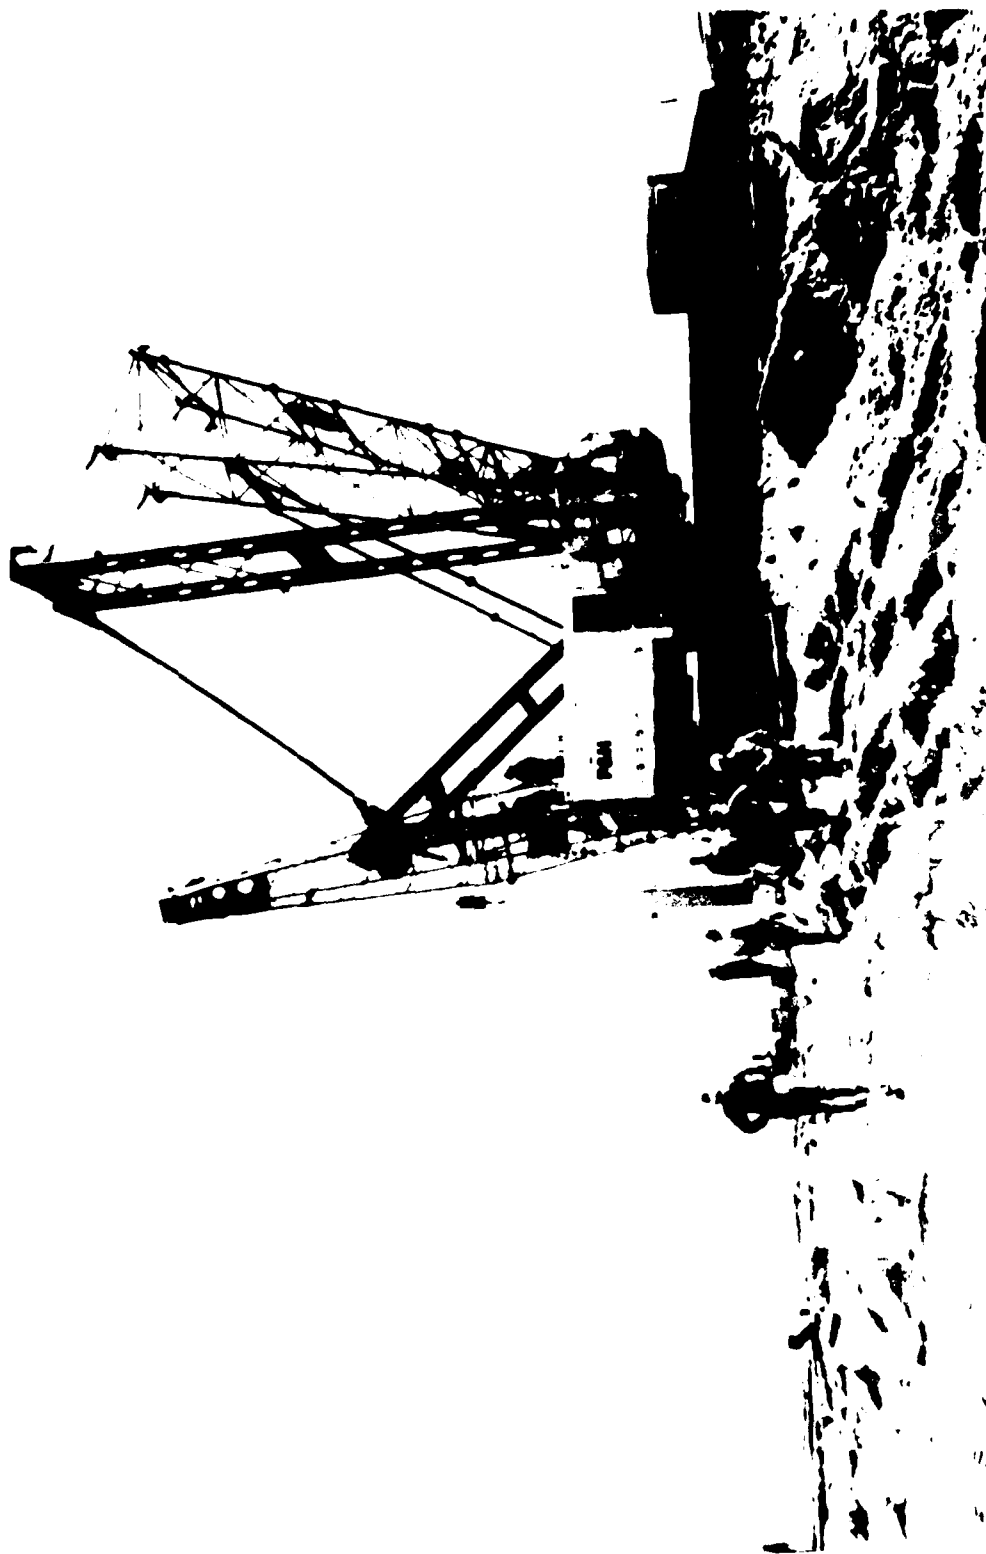
FIGURE D.59. 140-TON CRANE ASSISTS. To recover time lost in turning the 300-ton crane, a 140-ton crane assisted in reassembly. Normally, the 300-ton crane can make itself operational without assistance.

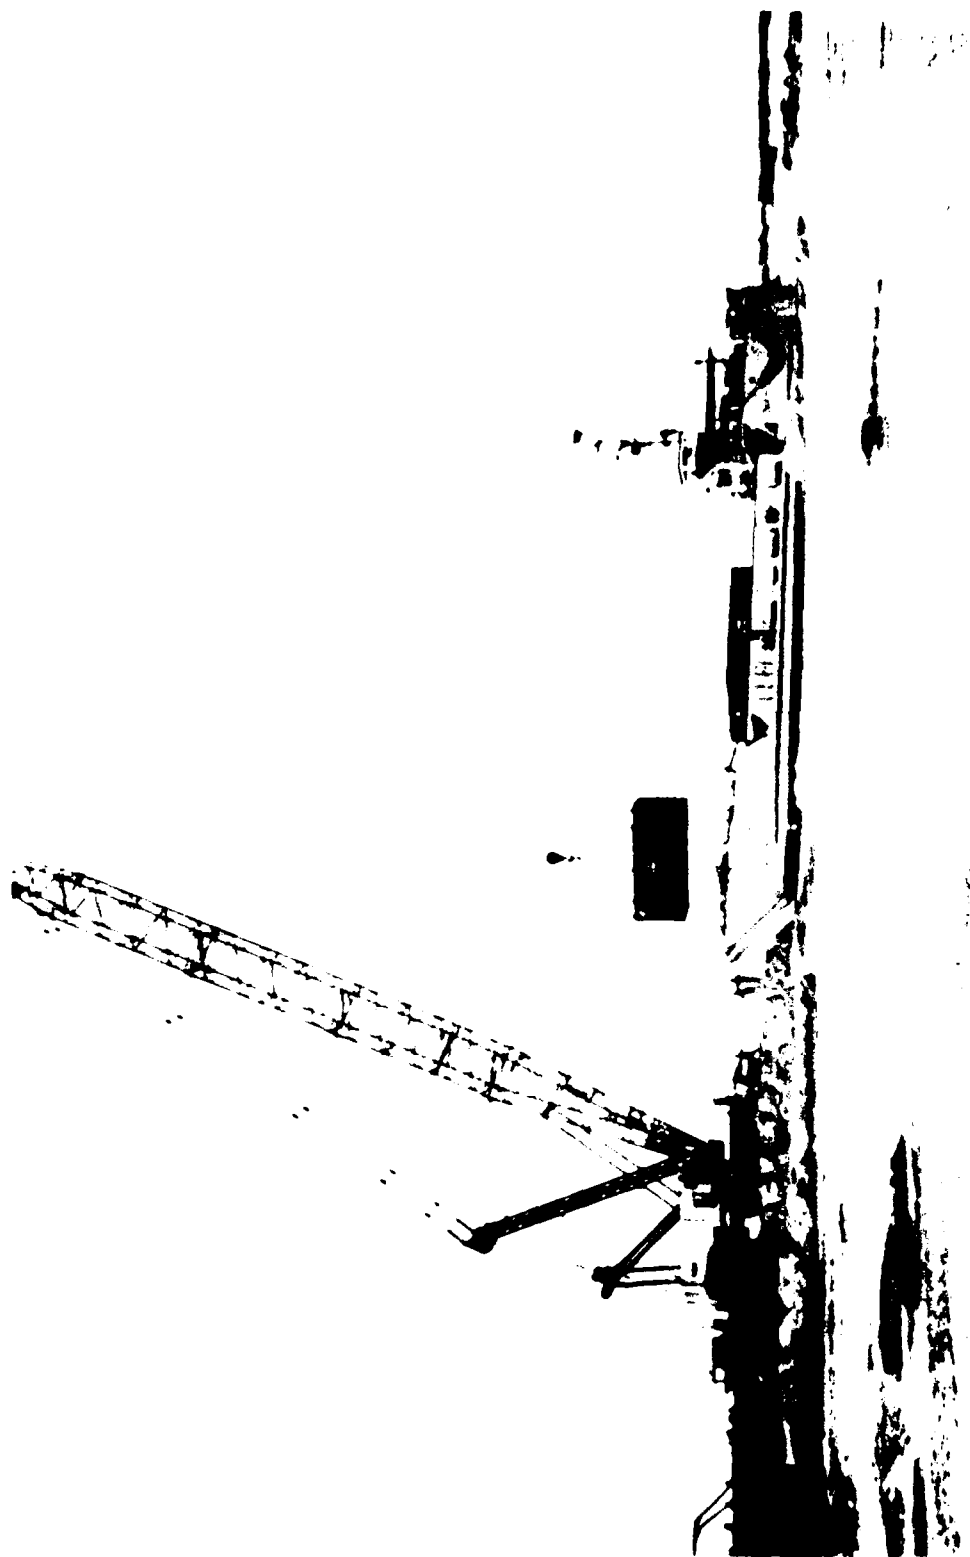
FIGURE D.60. HIGH TIDE OPERATIONS. At high tide landing craft were able to beach within reaching distance of the beach crane and were unloaded without difficulty.

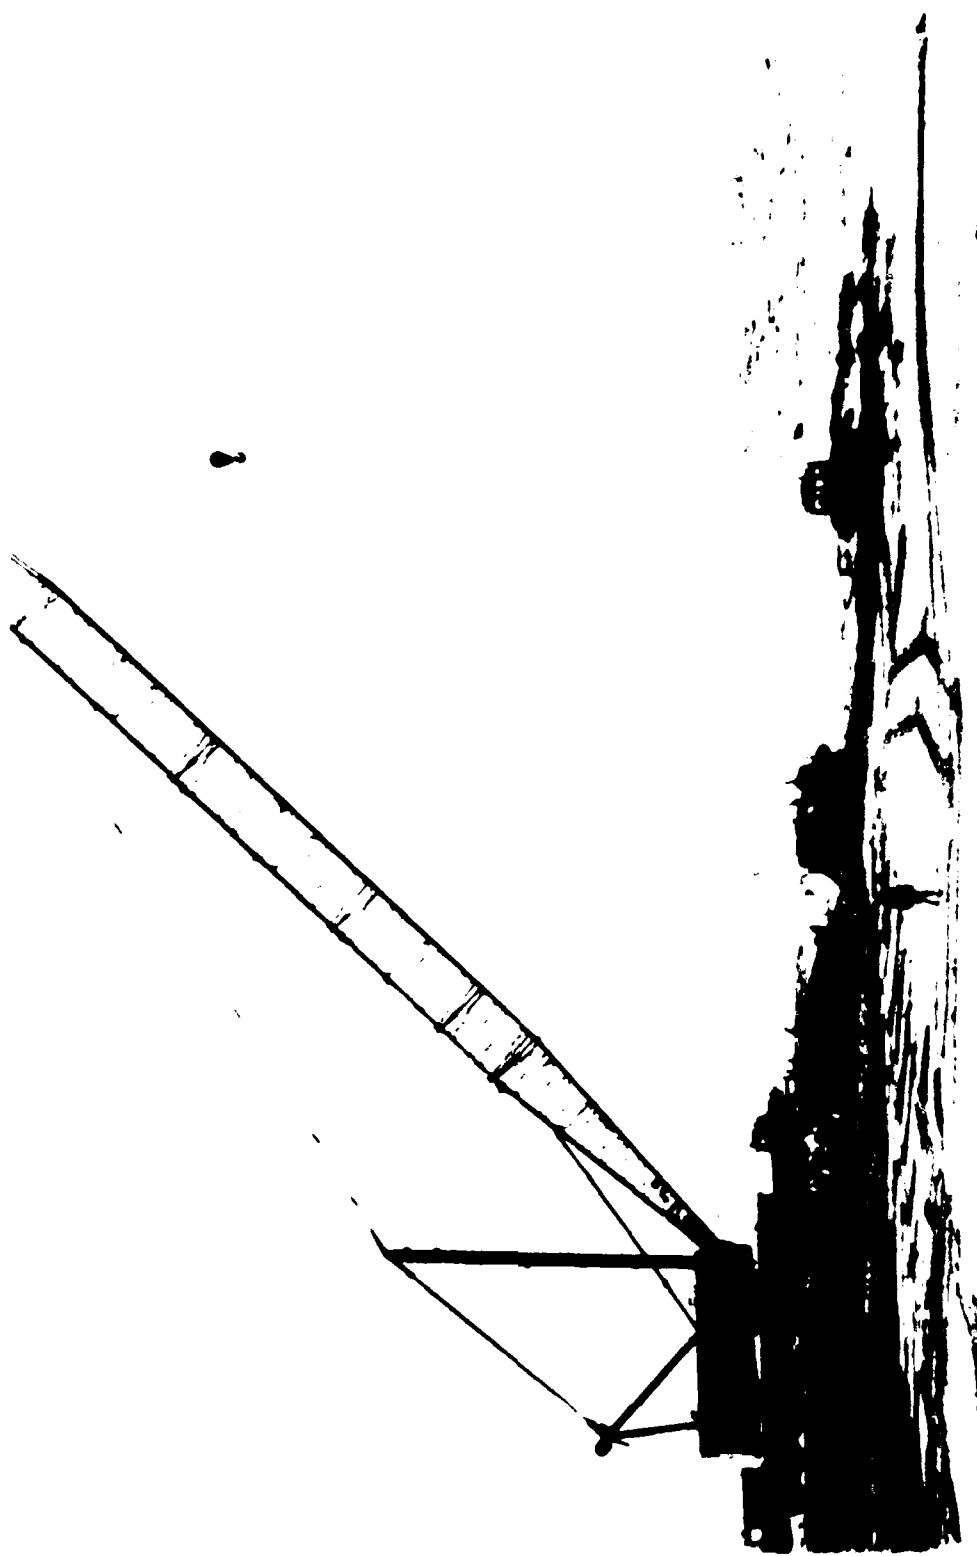
FIGURE D-64. CHANNEL 17 BY 14. After approximately 15 hr of dredging, it was apparent that a channel deep enough could not be excavated. The above photo was taken about 30 minutes before low tide.

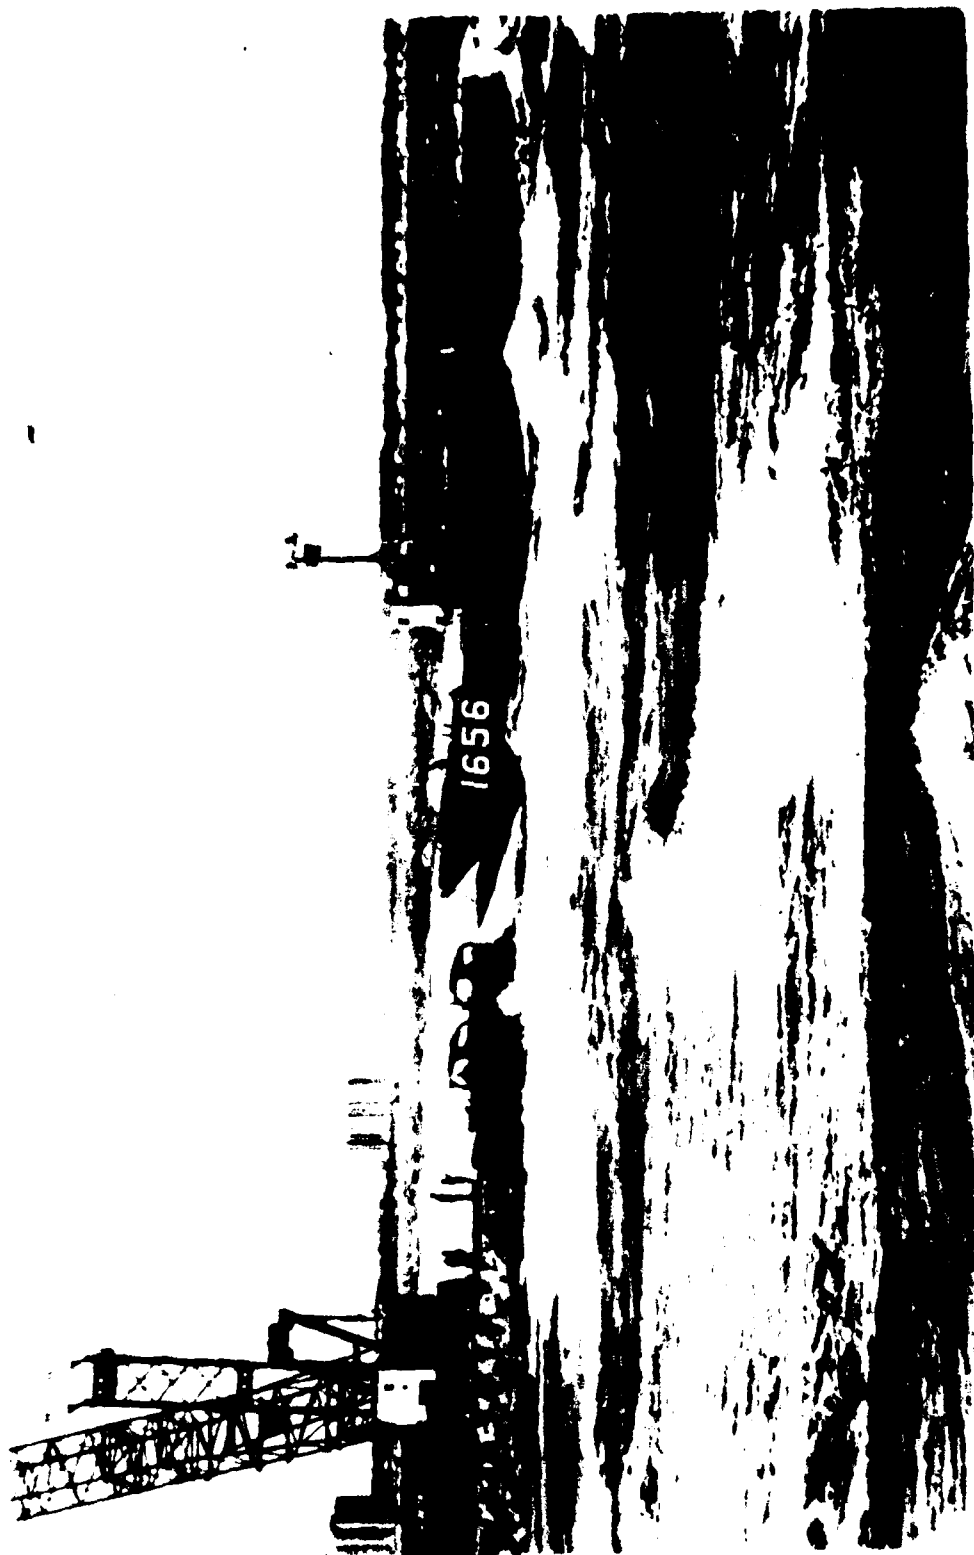
FIGURE D.65. ROUGH WEATHER EXPERIENCED. Another problem was encountered when the surf and winds increased. The sand ramp upon which the crane had been placed began to erode and had to be repaired at high tide by dozers.
